Arista VARP, IPv6 and fall-out

Henrik Lund Kramshøj hlk@nordu.net

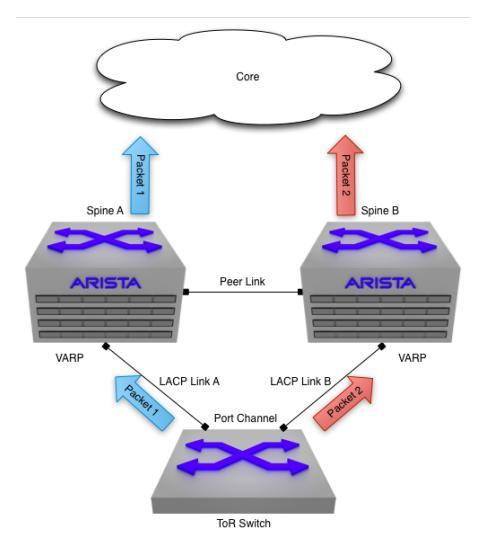
NORDUnet Overview VARP

- Router 1 has MAC address aa:aa:aa:aa:aa:aa
- Router 2 has MAC address aa:aa:aa:aa:aa:aa
- These MACs are used for the default gateway IP addresses
- Nearest switch/router pick up traffic, and forwards it on Layer 3

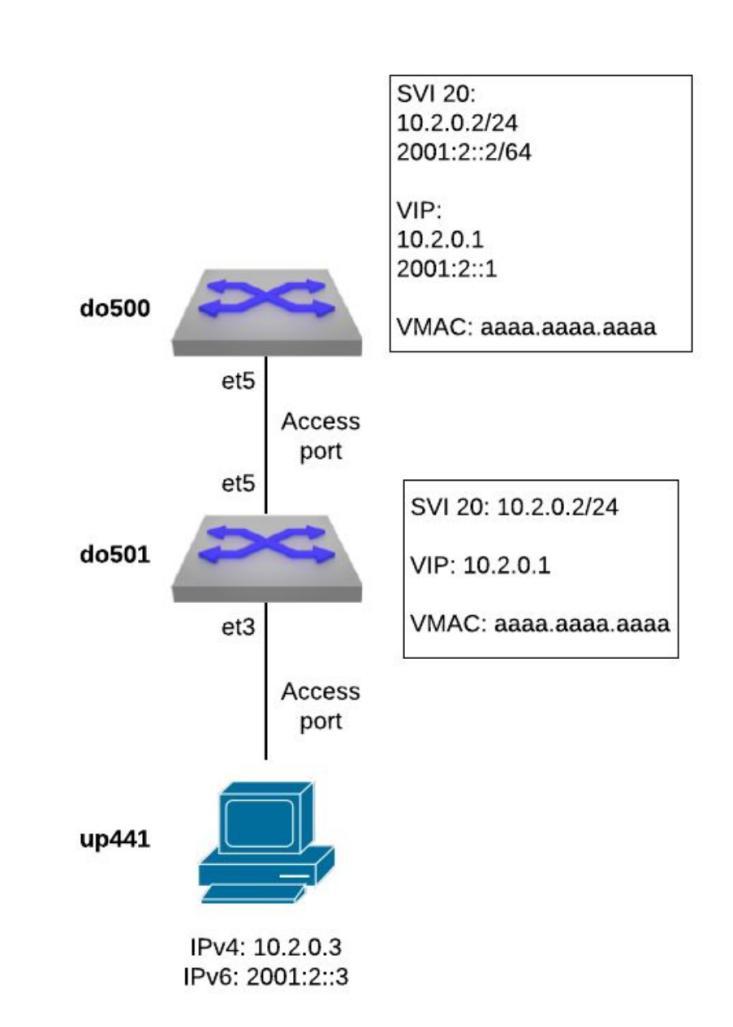
Arista support topology

<u>Test 1:</u>

Ping results: Ping to physical IP (2001:2::2) on switch do500 was successful from host up441: up441#ping ipv6 2001:2::2 PING 2001:2::2(2001:2::2) 72 data bytes 80 bytes from 2001:2::2: icmp_seq=1 ttl=64 time=0.372 ms 80 bytes from 2001:2::2: icmp_seq=2 ttl=64 time=0.127 ms 20 However, ping to IPv6 virtual address failed from the host: up441#ping ipv6 2001:2::1 PING 2001:2::1(2001:2::1) 72 data bytes --- 2001:2::1 ping statistics ---5 packets transmitted, 0 received, 100% packet loss, time 4003ms

ip virtual-router mac-address aa:aa:aa:aa:aa:aa:aa interface Vlan123 description NDN-Testnet ip address 109.105.123.2/25 ip virtual-router address 109.105.123.1 ipv6 address 2001:948:123:4::2/64 ipv6 virtual-router address 2001:948:123:4::1

After digging deeper, I found that we are treating this as an expected behavior with the current code implementation. I also found RFE40072: 'Packets to VARP MAC should be switched if SVI is down', which has been already filed to change this behavior and have added Nordunet as an interested customer for this feature request. Since it is expected for the Arista switch to consume packets destined to VMAC if the SVI has not been configured on the VLAN
